Shore Testing:

BY DAVID J. HAMMOND

BECAUSE OF ITS AVAILABILITY AND VERSATILITY, wood shoring is widely used to temporarily stabilize damaged structures during urban search and rescue (US&R) operations. Shoring systems have been developed using well-accepted engineering principles and design specifications. Testing conducted in California since 2000 has sought to verify predicted strengths, and more importantly, the failure characteristics of vertical and lateral wood shoring systems. The sites included the Menlo Park (CA) Fire District, Federal Emergency Management Agency (FEMA) US&R California Task Force 3 (CA-TF3) training site, and the Moffett Field, the National Aeronautics and Space Administration /Ames Research Center (NASA/ARC) Disaster Assistance and Rescue Team (DART) training site.

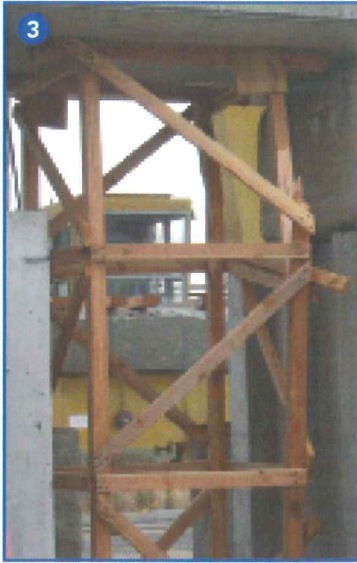
(3) The typical conditions at failure. Test specimen LP-31's right-front post split at a knot near the intersection of the upper mid-brace and two diagonals. (4) At the upper right, the right-front post has crushed the header to about half its thickness, which displaced the then-standard 12 x 12-inch full gusset. The standard now recommends using 6 x 12-inch half-gussets, which are quicker to install and allow a better view of the crushing of the header. (5) The right-front post at failure load (3.2 times the design load) crushed the wedges and caused them to cup. Crushing and cupping are quite obvious at about two times the design load and indicate that shore is overloaded and personnel must take action.

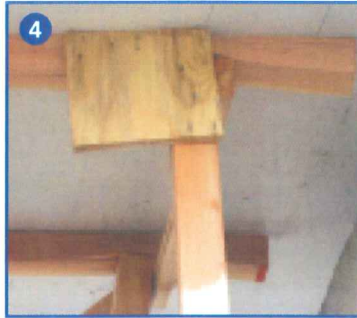
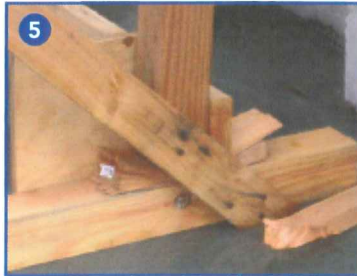
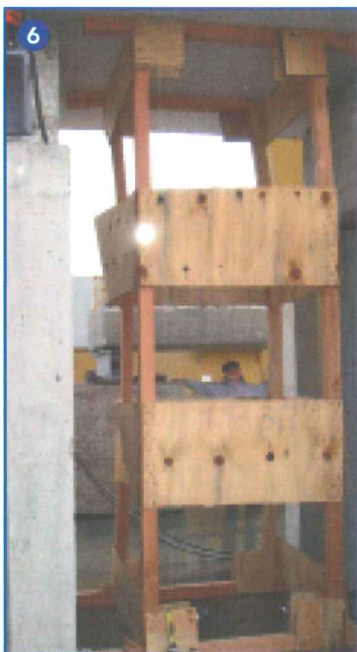
(6) Typical failure conditions. LP-32's two rear posts fractured at knots near the top of the upper plywood lacing, and the right-front post crushed the header to about half its thickness, displacing the gusset. (7) The plywood lacing deformed as the shore failed. However, note that the face-grain of the plywood is running in the short direction, instead of the long direction. The plywood's mis-orientation was the shore builders' error. The plywood lacing performed better in other tests when the face-grain was aligned with the long-direction (i.e., from post to post). (8) The post has crushed the wedges and caused them to cup. Note

how the plywood gusset has started to buckle as the sole is crushed. Placing the gussets about 3/4-inch or so below the top of the header and above the bottom of the sole prevents this. If the shore's actual load is close to the design load (as it should be), crushing would not occur.

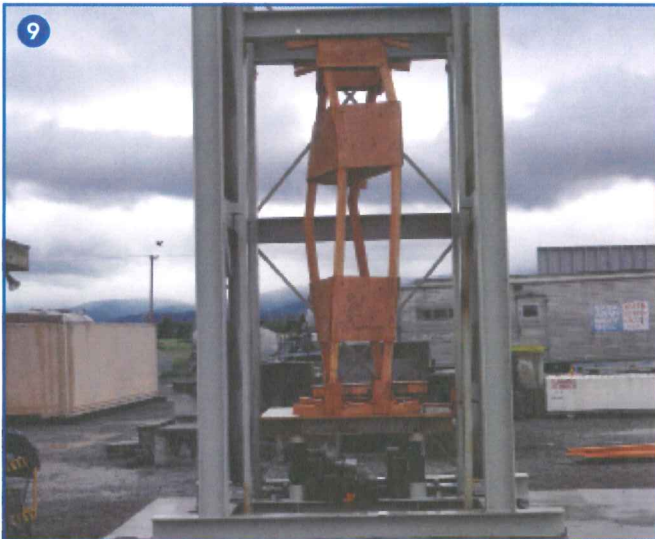
(9) The final version of the 2-foot × 4-foot PLP at failure. The posts fractured at knots and the headers and soles gave ample warning of failure as they were crushed and split. (10) PLP-85 after failure, showing extent of crushing of sole, and cupping of wedges. The failure load was 140k (4.4 times design load), which is attributed to the uniform straightness and absence of knots in all four posts.

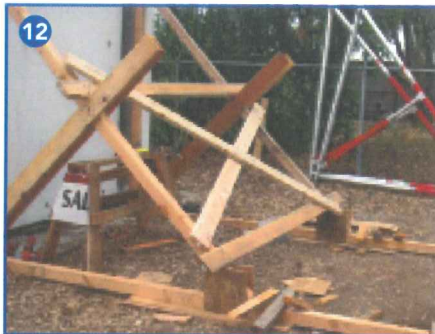
(11) Typical test setup for testing a pair of solid sole rakers. (12) Raker pair after sole cleat fly-off; nails were reduced to only six. (13) Pneumatic raker system with lateral bracing. (14) Test of redesigned pneumatic raker.

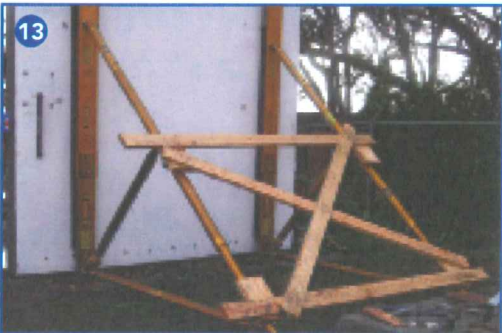
Since the test of the braced system resisted the 25k load without failure, the lateral bracing was removed, and the system was reloaded to 25k. It appeared that the raker struts would begin to buckle if the load was increased much beyond 25k. This manufacturer's strut raker system performed well enough to be used as a substitute for wood rakers. The braced system is shown in photos 13.

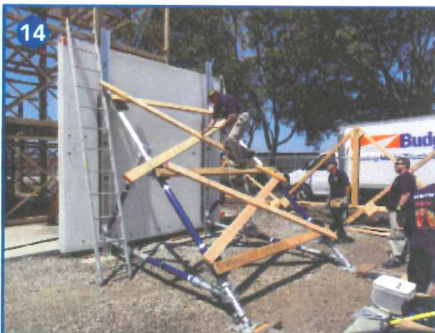
The redesigned raker system was tested in May 2011 during StS2 training, and supported 25k. without failure (photo 14). This strut raker system performed well enough to be used as a substitute for wood rakers.
