Shore Testing:

BY DAVID J. HAMMOND

BECAUSE OF ITS AVAILABILITY AND VERSATILITY, wood shoring is widely used to temporarily stabilize damaged structures during urban search and rescue (US&R) operations. Shoring systems have been developed using well-accepted engineering principles and design specifications. Testing conducted in California since 2000 has sought to verify predicted strengths, and more importantly, the failure characteristics of vertical and lateral wood shoring systems. The sites included the Menlo Park (CA) Fire District, Federal Emergency Management Agency (FEMA) US&R California Task Force 3 (CA-TF3) training site, and the Moffett Field, the National Aeronautics and Space Administration /Ames Research Center (NASA/ARC) Disaster Assistance and Rescue Team (DART) training site.

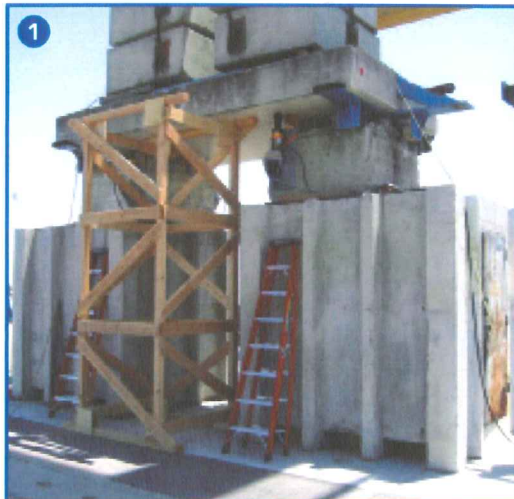
(1) OARF-2 test setup. Photos courtesy of author. (2) Vertical load tester (280k-VLT) test setup.

In November 2005, the OARF test setup was modified to more precisely measure the loading during the test and at failure. Four 50-ton hydraulic rams supported on steel brackets were installed symmetrically under the slab and loading blocks. The rams would lift the load while the shore was placed under the slab; the load was applied to the shore by reducing the pressure on the rams (i.e., lowering the slab and blocks) and the change in pressure on the rams would accurately determine the load on the shore. As above, the total possible load was the 38k slab and four pairs of 12.5k blocks (138k total). This test setup was called OARF-2 (photo 1).

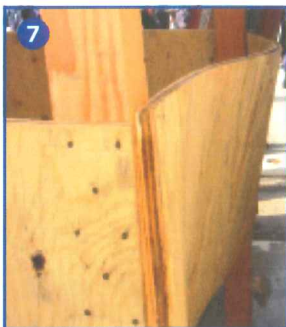
(6) Typical failure conditions. LP-32's two rear posts fractured at knots near the top of the upper plywood lacing, and the right-front post crushed the header to about half its thickness, displacing the gusset. (7) The plywood lacing deformed as the shore failed. However, note that the face-grain of the plywood is running in the short direction, instead of the long direction. The plywood's mis-orientation was the shore builders' error. The plywood lacing performed better in other tests when the face-grain was aligned with the long-direction (i.e., from post to post). (8) The post has crushed the wedges and caused them to cup. Note

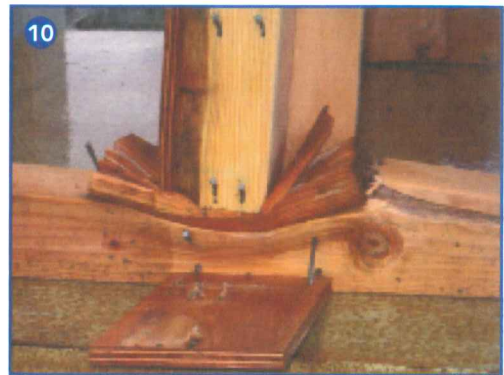
(9) The final version of the 2-foot × 4-foot PLP at failure. The posts fractured at knots and the headers and soles gave ample warning of failure as they were crushed and split. (10) PLP-85 after failure, showing extent of crushing of sole, and cupping of wedges. The failure load was 140k (4.4 times design load), which is attributed to the uniform straightness and absence of knots in all four posts.

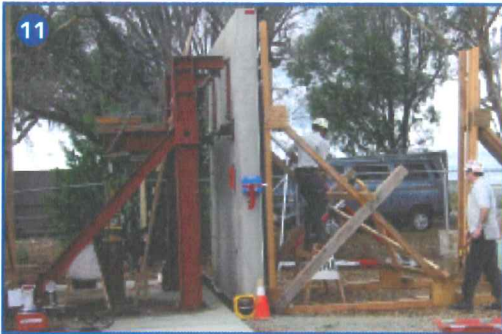
(11) Typical test setup for testing a pair of solid sole rakers. (12) Raker pair after sole cleat fly-off; nails were reduced to only six. (13) Pneumatic raker system with lateral bracing. (14) Test of redesigned pneumatic raker.
